# FLOOD INSURANCE STUDY

VILLAGE OF  
LIMESTONE,  
NEW YORK  
CATTARAUGUS COUNTY

OCTOBER 1977

U.S. DEPARTMENT of HOUSING & URBAN DEVELOPMENT  
FEDERAL INSURANCE ADMINISTRATION

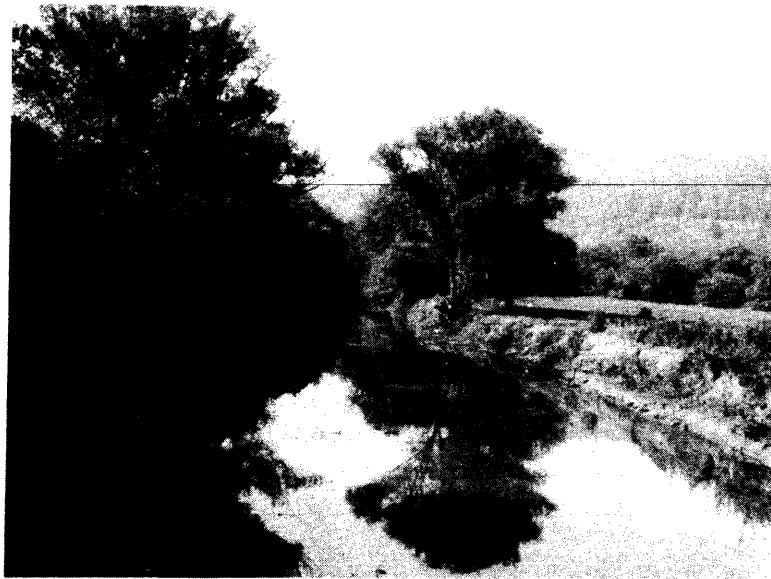
Figure 2

Tunungwant Creek at Limestone  
(Looking North at River Street)

Some portions of the flood plain within the study area are illustrated by photographs in Figures 2 and 3.

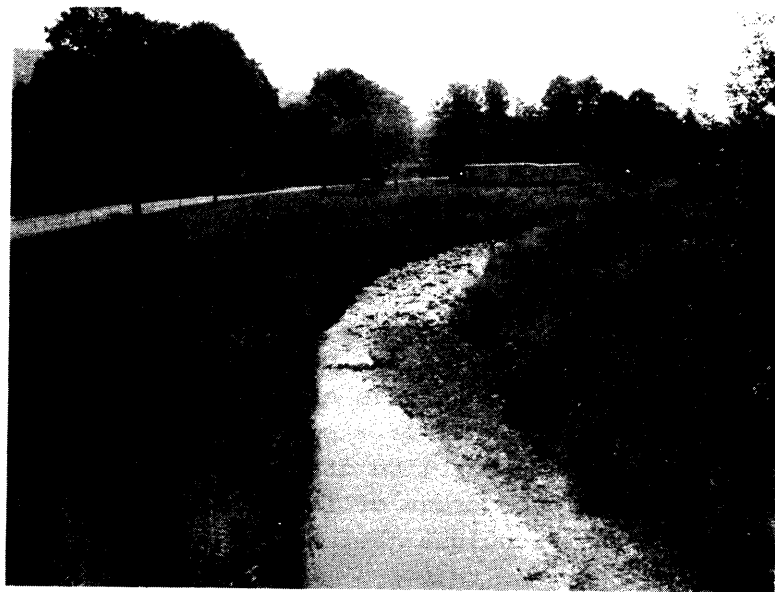
Figure 3

Nichols Run at Limestone  
(Looking East at Main Street)
